RESTORING A CORRODED SEWER (CONT'D)

CASE STUDY: RESTORING A CORRODED SEWER

ORIGINALLY PUBLISHED IN TRENCHLESS WORLD, JULY/AUGUST 2011

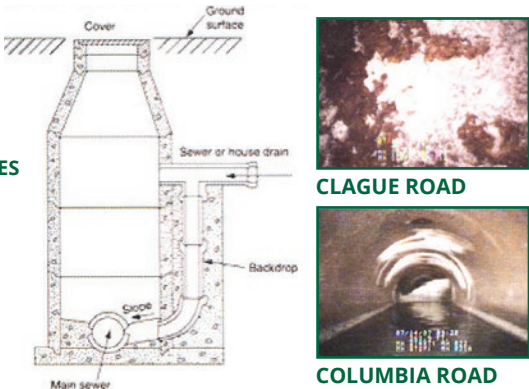
HYDROGEN SULFIDE CORROSION WAS SEEN AT ALL MAJOR TRUNK LINES (6) DUE TO DROP MANHOLES

- 50' +/- Manhole
- Remainder Good Condition

Pictured: Typical manhole (left) with typical effects of corrosion (right)

At the majority of locations, corrosion from sulphuric acid was confined to within 7.5-15m either side of the manhole, with the remainder of the interceptor in good condition. This concentration resulted from trunk lines with drop connections.

As a possible solution, cured-in-place pipe (CIPP) was reviewed first. However, since the entire sewer run was not being repaired, partial liners for the deteriorated sections of that size diameter pipe were not feasible. The city then decided to perform the rehabilitation using centrifugally-cast concrete pipe (CCCP). A spray-applied cementitious coating with an anti-microbial agent called ConShield, made by AP/M Permaform.

The CCCP coating was applied as a 12mm-thick layer on the surface of the prepared pipe by a spin-caster; this was pulled through at a uniform rate using compressed air to apply the pumped, cementitious coating around the circumference of the pipe.
