Northcrest-Afton Sewer Rehabilitation Project

## **Multiple Technologies -- Maximum Flow Reduction**

James W. Shelton<sup>1</sup>, and Michael T. Harmer<sup>2</sup>

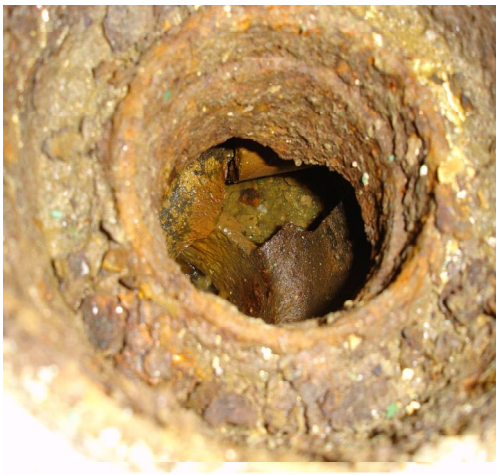
Smoke testing confirmed that there were no roof drains or cross-connected sewers, but door-to-door basement inspections confirmed the presence of illegal sump pumps and punctured floor drains. Most of these were found to be from the original construction of the homes. In a neighborhood with shallow bedrock under clay, many natural springs, and basements with underlying sewer laterals, this spelled high flows during wet and dry flow conditions.

Figure 3: Punctured Floor

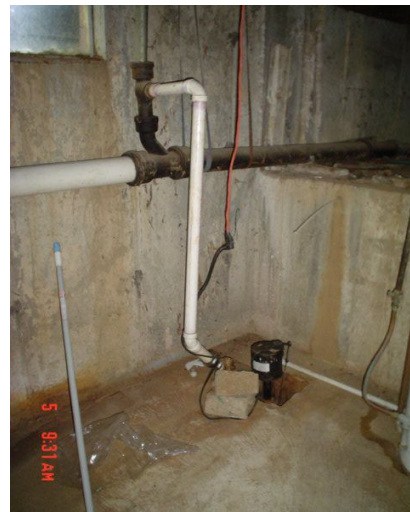
Figure 4: Illegal Sump Pump

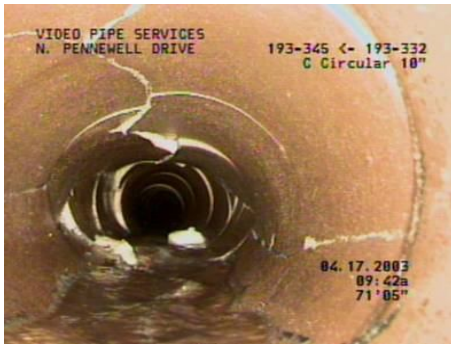
Once determined to be a *Leaker*, the sewers of NCA were inspected to determine the most appropriate rehab methods to use to reduce the I/I. This involved <sup>1</sup>NASSCO PACP-coded CCTV inspection. As expected, the predominantly terracotta clay sewer showed numerous cracks and fractures, and several instances of broken, distorted, or collapsed pipe. Unexpectedly, many of the segments of terracotta pipe were in perfect structural condition, suffering only from leaking joints.

Figure 5  
Structurally Compromised Pipe

Cured-In-Place-Pipe-Lining (CIPPL) was selected for rehabilitation of the sewer mains with structural defects. Approximately 3800 linear feet of mainline pipe was lined. Polyester resins combined with non-woven tube and cured with steam by Am-Liner East, Inc. provided strong, smooth plastic pipes to function as pipe replacements or pipe liners inside cracked, fractured, and broken terracotta pipe. CIPPL liners for this project were all conservatively designed for fully deteriorated host pipe conditions under fully saturated soil conditions under highway

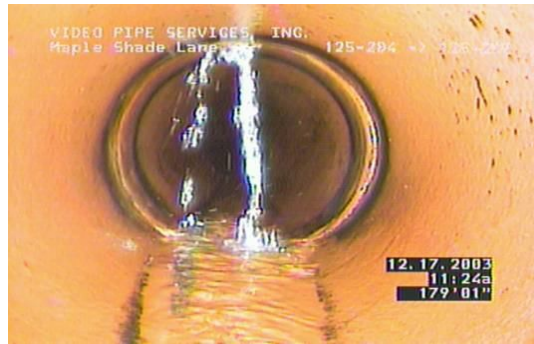
Figure 6  
Structurally Sound, but Leaking Joint

Packer injection grouting, or test and seal, was selected for those pipe segments that had no structural defects. Video Pipe Services of New Jersey used Avanti's AV-100<sup>®</sup> chemical grout, which, mixed with Dichlobenil for root retardation and Avanti's IcoSet<sup>®</sup> for strength retention, proved sufficient to seal the leaking joints. This was so much the case that lateral taps that had not been leaking prior to mainline grouting began leaking afterward. Approximately 3,900 linear feet of mainline pipe had its joints tested and sealed. Joint failure rate was 15%.

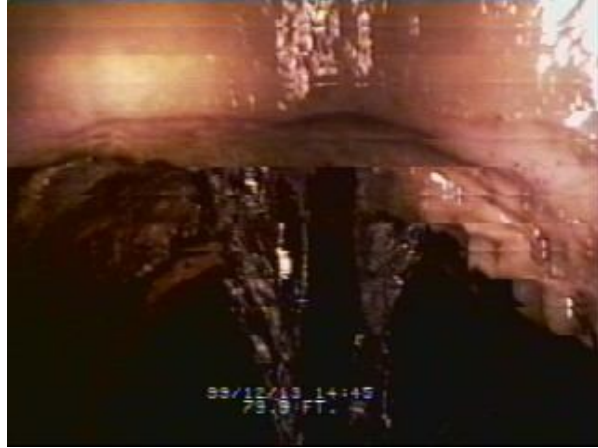
Figure 11: Leaking CIPPL Tap Cut

To prevent the leakage in the annular space between the host pipe and the liner from coming out at the tap connection cuts, for laterals connected to segments receiving CIPPL, each lateral tap received a cured-in-place lateral liner (CIPLL) using LMK T-Liners<sup>®</sup>. The T-Liner<sup>®</sup> provides a full mainline wrap, integrally sewn and cured with the lateral pipe liner, and installed with its own double layer of hydrophilic end bands to prevent annular space leakage from coming into the pipe.
