North American Society for Trenchless Technology (NASTT)
NASTT's 2014 No-Dig Show

MA-T3-02

Rehabilitation of the Coral Gables Wastewater Collection System

Sahar Hasan, LMK Technologies, Ottawa, IL
Mark Gulyas, LMK Pipe Renewal, Ft. Lauderdale, FL
Jorge Acevedo, City of Coral Gables, Coral Gables, FL

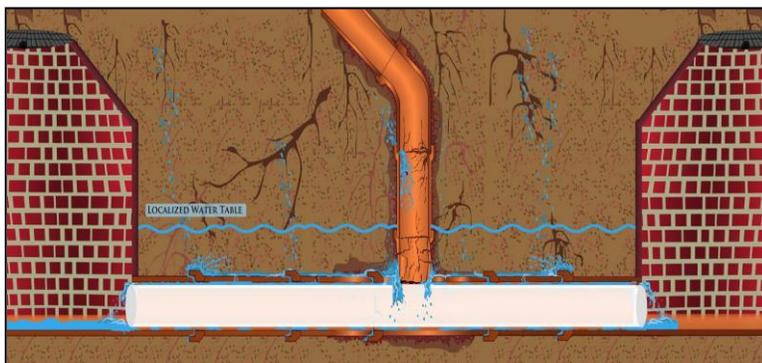
Figure 4: Water Reentering the System Post Mainline Rehabilitation

The first objective was to reduce the amount of water infiltrating into the system by installing liners during low tides. Chemical grout (Avanti AV-100) was pumped using a Logiball® Lateral Packer to control the seawater infiltrating the system. The grout was injected into lateral connections and manholes. Chemical grout was also injected between the host pipe and the existing folded mainline liner (6,256-feet from a previous lining project) that did not include end seals.

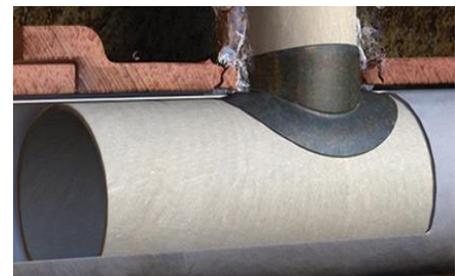
Figure 6: Main to Lateral Connection Gasket

deadhead the liner into a capped sanitary tee fitting. A total of 74 service lateral pipes were rehabilitated using an ASTM F2561-11 compliant CIPP liner which includes compression gasket seals at the connection to eliminate infiltration into the collection system as shown in Figure 6. The average length of the rehabilitated lateral was 24-feet and every lateral liner was also outfitted with compression end seals at the upper end near the cleanout. Several of the lateral pipes required excavated point repairs due to settling and offset pipe sections.
