North American Society for Trenchless Technology (NASTT)
NASTT's 2014 No-Dig Show

TM1-T3-02

**A Technique for Renewing a Section of Mainline Pipe while
Simultaneously Renewing Multiple Service Lateral Pipes through the
Use of Continuous CIPP**

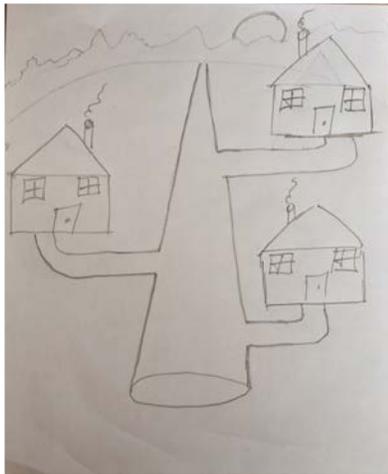
Fig 1. Typical Sewer w/ connections

<p>Sewer mains typically have lateral connections at various positions along the length of pipe, and these connections are seldom opposing.</p>	<p>Siamese Laterals are opposing and have been a challenge for CIPP lining. However, the need to apply trenchless CIPP rehabilitation is desirable for all pipe configurations.</p>	<p>By far, the most difficult pipe configuration is the double-stack, where the lateral pipe is at a 12 o'clock position and connects to a bullheaded tee fitting with two service laterals extending therefrom.</p>
---	---	--

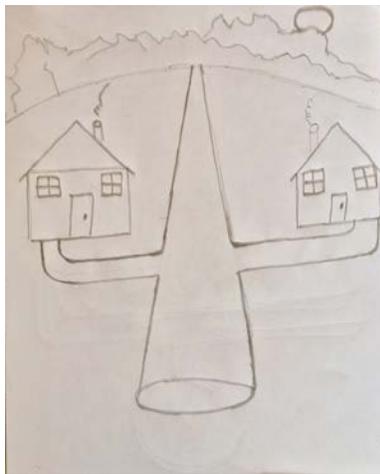
Fig. 2 Siamese Opposing Laterals

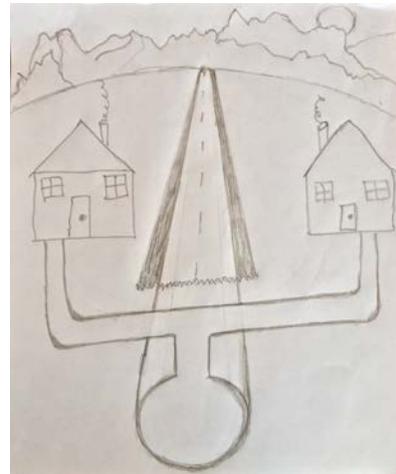
Fig 3. Double Tee Stack Connections

The notorious double-stack lateral is unique to South Florida where ground conditions are a concern even at shallow depths with running sand and water. Therefore, the thought was to use a single lateral connection positioned at 12 o'clock and go straight up with the pipe to an elevation that was much less than the main pipe depth. A bullheaded tee fitting, as shown in Figure 11, is connected to the vertical lateral pipe, and two lateral pipes on a horizontal grade are connected to the left and right sides of the tee.

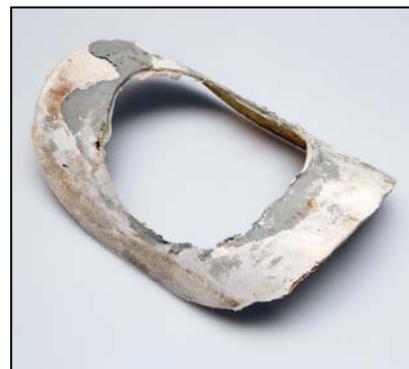
Fig. 4 Glued Brim Style Connection

CIPP has been used for a wide variety of pipe repairs and pipe renewal projects. In the early 1990s, lateral lining techniques were developed for the insertion of a cured in-place liner into a service pipe from within the main pipe. These liners were pulled in-place and inverted in-place, and attempts to form a seal at the main/lateral connection were made by gluing a brim to the mainline CIPP (see Fig. 4). The concept of using glue to form a long-term bond in a greasy sewer where hydraulic loading is prevalent proved to not be the best option. Often these types of glued connections delaminated. Another disadvantage was the lack of engineering. Since the brim does not take the shape of a tube, the design calculations described in ASTM F1216 are not applicable.

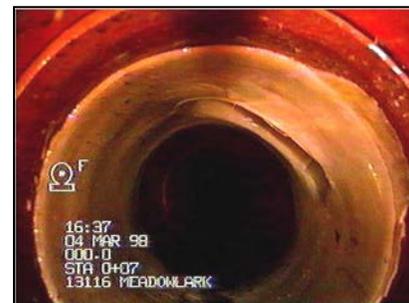
Fig 5. Glued Full-Hoop Connection

In 1995 a pull in-place liner was developed, and in 1997 an inverted liner was developed; both included of a full-hoop structural connection liner designed to bond with the mainline CIPP. Although the full-hoop construction (see Fig. 5) allowed engineers to design the lateral tube and the connection liner to withstand specific loading, specifically hydraulic loading, the repairs were prone to leak due to a lack of long-term bonding caused by lubricants applied to the coating of the mainline CIPP. The lubricant materials may include mineral oil, vegetable oil, Crisco® grease and similar materials that are slippery and slick. These materials are directly

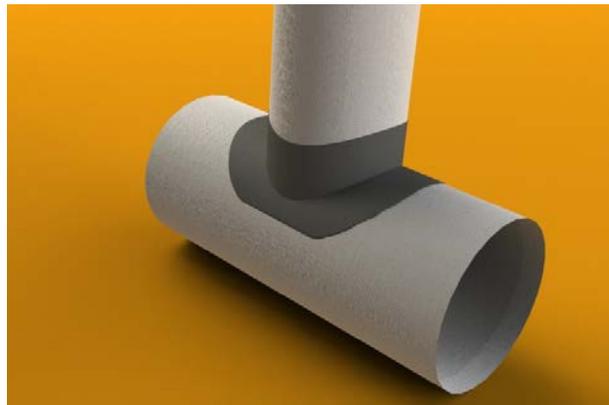
Fig 6. Full-Hoop Lateral Connection Liner with Neoprene Compression Gasket

The next generation of lateral lining was engineered with a compression gasket (see Fig. 6) that forms a positive seal between the mainline CIPP and the full-hoop lateral connection liner. The gasket sealing technology is a proven method of sealing CIPP and has been successfully tested to withstand up to 70-feet of hydraulic head pressure. However, service lateral pipes come in many different shapes, sizes, and configurations. When we studied the three different pipe configurations shown above, we found that all three (3) CIPP processes for lateral pipes were unsuitable methods of renewal and sealing for pipe configurations shown in figures 2 and 3, which will be discussed in greater detail below.

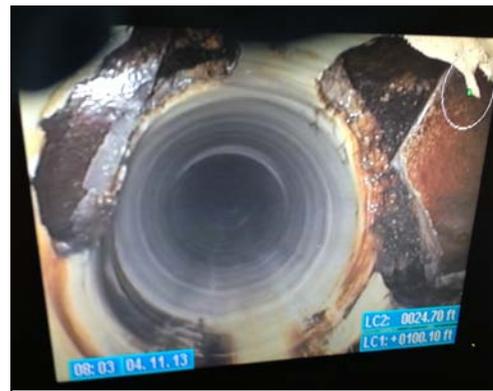
Fig. 7 Lateral Connections New Castle County

The other option was to install two (2) brim style lateral connection liners, but this type of repair does not meet the requirements as described in the industry standard for lateral renewal and sealing and therefore would be prone to leakage. The contractor contacted their CIPP supplier about the situation in Fort Meyers and discovered that a new technology had recently been developed for the simultaneous installation of a full-hoop lateral connection liner into two lateral pipes, outfitted with neoprene compression gaskets. The simultaneous inversion of multiple liner tubes is a technology that had been under development for several years. The first commercial installation was in 2013 in New Castle County, Delaware. The repair shown in Figure 7 is an example of how sewers have evolved. The main pipe was installed, and at a later time, service connections were made by chiseling a hole in the clay tile. This is commonly referred to as a “hammer tap”. In this case the circumferential rings of the two connections were slightly offset only by a few inches. The crew took distance measurements from the manhole to the edge of each service opening, and the clock reference positions were a visual call made by the CCTV operator.

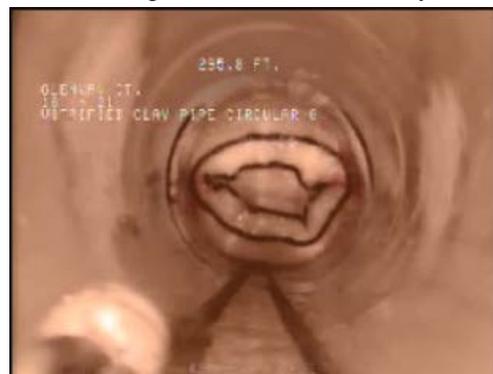
Fig. 8 Inverting Liner Outfitted with Compression Gaskets

The process consisted of a mainline liner tube and two lateral tubes. The mainline tube in this case was 8-inches in diameter and 3-feet in length. The two lateral tubes were 6-inches in diameter and also 3-feet in length. The liner assembly was married with a corresponding invertible translucent bladder, forming a liner/bladder assembly. Next, the liner assembly was resin saturated under a controlled vacuum and loaded inside of a hose-launching device. The launcher was pulled into the pipe adjacent to the connections, air was applied, and the main liner inverted towards the connections. When the liner reached the connection, the two lateral liners inflated and inverted into the service lateral pipes. The bladders extended beyond the liner tubes so the ends of each liner (the main and the two laterals) remained open ended and pressed tight to the host pipes. Each end of the main and lateral liner tubes were also outfitted with hydrophilic O-rings that swell after 24-hours from installation (long after the liner has been cured into a structural tube) forming a compression gasket seal that ensures the liners remain leak-free for the engineered 50-year service life.

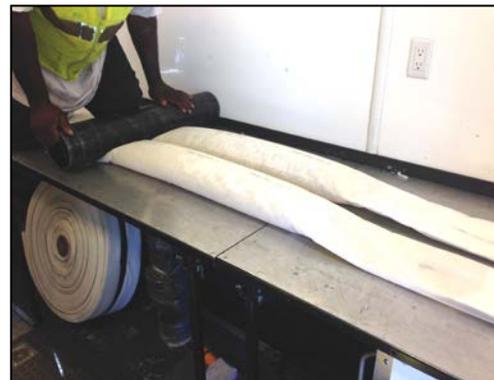
Fig. 9 Resin Saturation Siamese Laterals

This same process, which was first used on the New Castle County project, was also used to solve the concerns on the Fort Myers project. However, in this case, the lateral tubes needed to be 50-60 feet long each. The owner required the liner to be compliant with ASTM F2561-11, which requires that the liner be continuous with no cold joints and outfitted with compression gaskets (see Fig. 8). The pipes were surveyed, and measurements were taken. In this configuration, the laterals were Siamese factory made four-way tee fittings, so the clock positions of the connections were constantly positioned at 3 o'clock and 9 o'clock. These repairs were not easy by any means. The resin saturation process was a bit awkward, especially since the saturation process takes place in a mobile wet-out trailer. A vacuum source was attached to each lateral liner tube, and the slug of resin was pushed through both lateral liners at one time (see Fig. 9). These liners are saturated with 5-10% excess resin for the purpose of filling open joints and fractures in the old pipe as described in ASTM F2561 & ASTM F1216. The mainline connection liner, which was 3-feet long, was also vacuum saturated, and the liner/bladder assembly was loaded into a hose launcher and pulled to a location just adjacent to the lateral connections. The crew inserted lateral push cameras into each service lateral through a cleanout. In addition, a mainline camera was positioned in front of the inverting mainline tube, ensuring all three liners were fully deployed. The operators are trained to look for resin slugs at the uppermost end of the lateral liners since all of these liners are saturated with excess resin. If any resin is found, it is removed before curing the liner, ensuring a smooth transition is formed. The liners were steam cured, the bladders were reverted away from the cured liner assembly, and flows were reestablished (see a complete repair in Fig. 9).

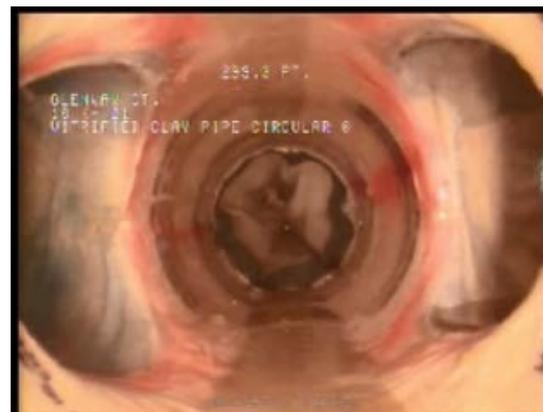
Fig 10. Continuous CIPP Siamese Lateral Connections

The repair of multiple lateral pipes through the inversion of a mainline liner tube and multiple lateral tubes having a uniform wall thickness (see Fig. 10) that is assembled, sealed and tested in a controlled factory setting, gives utility owners an engineered trenchless solution for these unique pipe connections. So far, as many as three (3) service laterals have been simultaneously renewed, along with the main connection, with compression end seals on all ends of the CIPP. Current testing is underway for the rehabilitation of the entire mainline run from manhole to manhole and all service connections there between through the inversion of a mainline tube having corresponding lateral liners connected along its length.

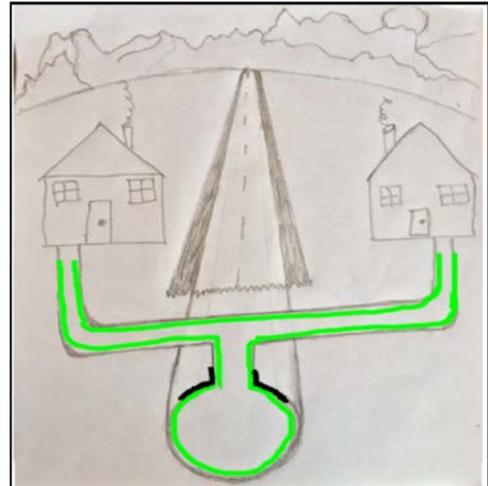
Figure 11 Monolithic Double-Stack CIPP with Gaskets

As described in ASTM F2561, the tube and sheet are the framework of the main and lateral cured-in-place liner (MLCIPL) and are generally constructed of an absorbent needle punched felt or a high pile knit with a polymer film coating on its outer surface. The tube is engineered to be extremely flexible yet robust in order to negotiate bends in lateral pipes at significantly reduced inversion pressures. In the case of the double-stacked laterals, special measuring equipment is used to determine the distance from the main pipe invert to the crown of the bullheaded tee fitting. The horizontal laterals were also measured using standard measuring methods. A bigger challenge was determining the clock-position of the double laterals in relation to the main pipe. All of these measurements were necessary for the liner to be constructed to match the pipe configurations.

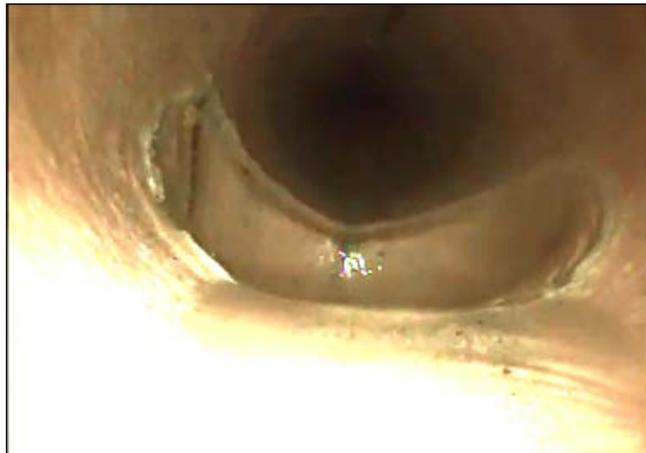
Fig 12. View from Cleanout of Bullheaded CIPP Tee at 6 o'clock

This style of repair utilizes the same equipment and installation methods used to renew a single lateral connection. The liner assembly consists of a flat sheet that forms a tube at the main connection and a lateral tube that is inverted into the lateral pipe. The lateral tube splits into two tubes matching the bullheaded tee fitting. This liner assembly is also married with a translucent bladder having corresponding shapes and sizes. The liner assembly is resin saturated under a controlled vacuum, loaded into a T-shaped launching device, and pulled to the lateral connection. A robot is used to align the lateral liner with the lateral pipe opening, air pressure is applied causing the liner to invert upward until the bullheaded tee is encountered, and the liner tubes begin to invert through the horizontal lateral pipes (see Fig. 12).
