TESTING TOP HAT LINERS AND ROBOTIC SYSTEMS FOR REPAIR OF LATERAL CONNECTIONS

Dr.-Ing. Bert Bosseler, Dipl.-Ing. Gunter Kaltenhäuser

IKT - Institute for Underground Infrastructure, Exterbruch 1, 45886 Gelsenkirchen,
Germany, e-mail: bosseler@ikt.de; kaltenhaeuser@ikt.de

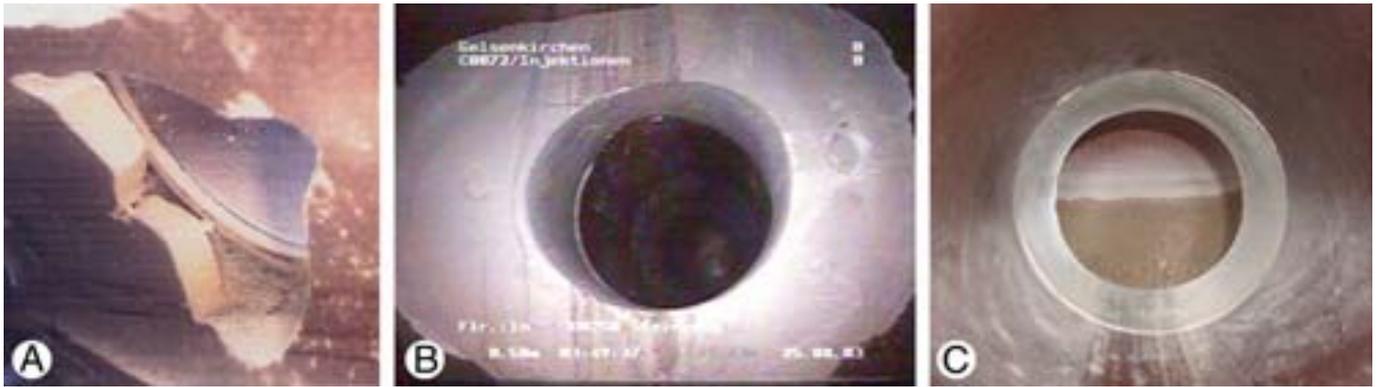
Figure 2. Standard damage for robotic systems and example of a visually satisfactory repair result. **A** Initial situation. **B** View from the main pipe. **C** View into the connecting pipe.

Unprofessionally installed lateral connection with strong borehole damage due to cracking and shard formation in a stoneware pipe DN 250 with stoneware connecting pipes DN 150 (see Figure 2 A).

The prepared damages were repaired in the appropriate test sections with the chosen methods. The participating network operators then assessed the re-establishment of the lateral connection operability by visual impression of the repairs. The respective standard damages were repaired visually satisfactory with the robotic systems and top hat liners (Figure 2 and Figure 3). Only three offerers could visually satisfactory repair the extreme damages foreseen for robotic systems (Figure 4). This can among other things be attributed to the applied technology. Some methods were e.g. not able to seal pipes connected in an acute angle with the inflatable piston or ballon for sealing the connecting pipe. The extreme damages for the top hat liners were only repaired visually satisfactorily by two offerers (Figure 5). Numerous repairs of the respective extreme damages were not visually satisfactory. The repair even worsened the condition of the lateral connections in some cases (Figure 6). In nearly all cases the top hat liner resin impregnation was only accomplished manually (Figure 7 A). A complete top hat liner surface impregnation cannot therefore be ensured. Only one offerer vacuum impregnated the top hat liner, thereby promoting complete impregnation (Figure 7 B).

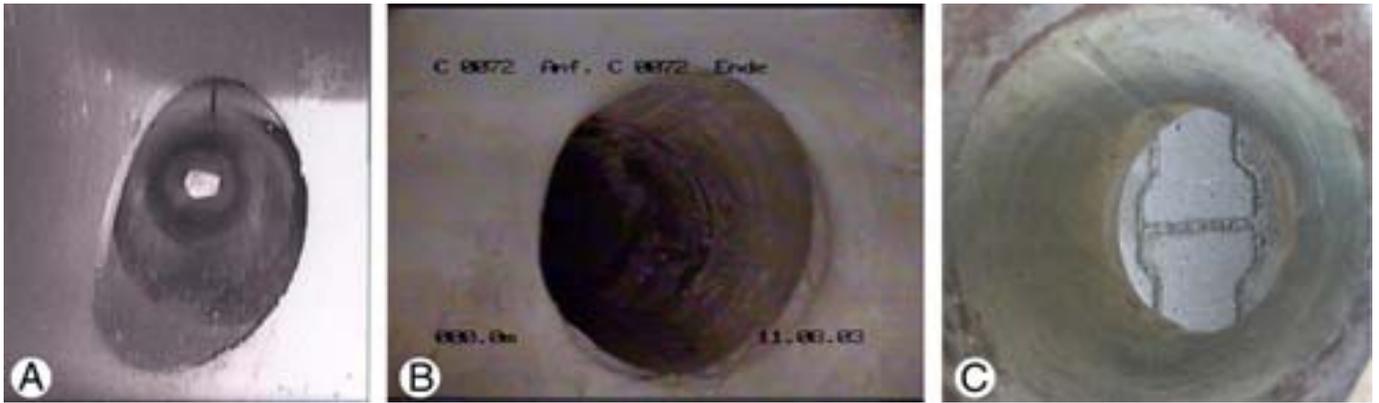
Figure 5. Extreme damage for top hat liners and example of a visually satisfactory repair result. **A** Initial situation. **B** View from the main pipe. **C** View into the connecting pipe (after disassembly).

Unprofessionally installed lateral connection with bent connecting pipe as well as a longitudinal crack in the connecting pipe in a GRP-pipe DN 500 with stoneware connecting pipes DN 150 (see Figure 5 A).

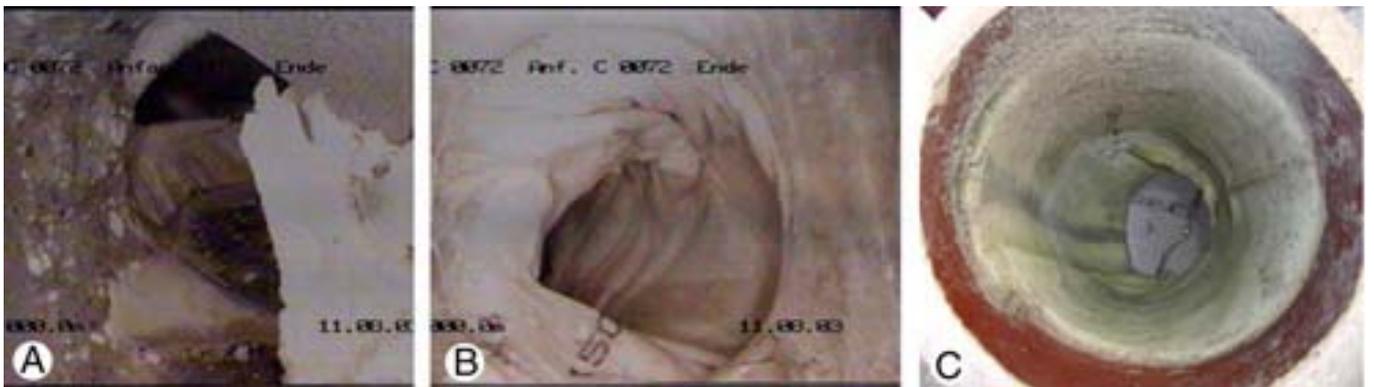
Figure 6. Examples of visually unsatisfactory repair results on extreme damages **A** Robotic system - view from the main pipe. **B** Top hat liner - view from the main pipe. **C** Top hat liner - view into the connecting pipe (after disassembly).

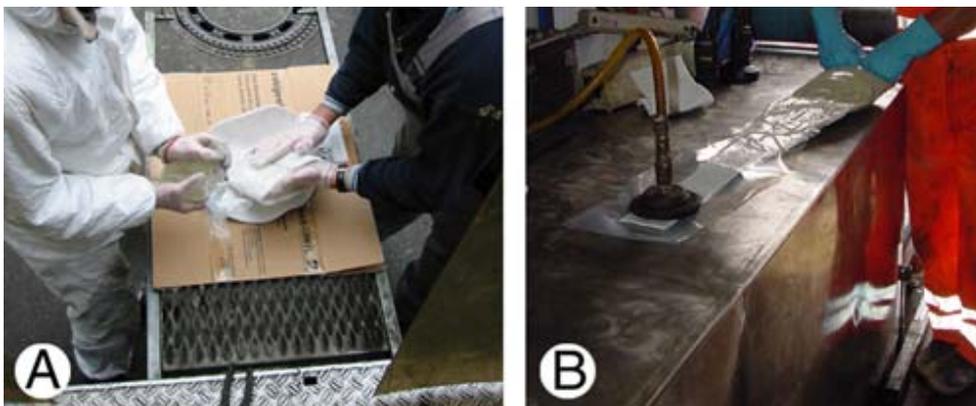
Figure 7. Top hat liner resin impregnation **A** Only manual resin impregnation. **B** Vacuum resin impregnation.
