The Most Cost Effective Method for Eliminating Inflow

Larry W. Kiest, Jr¹

Abstract: Manholes are a crucial part of the collection system. They serve as entryways to an extensive underground pipeline infrastructure. Today, the big picture is really the same as yesterdays and that is achieving the most cost effective and time saving methods for eliminating as much infiltration/inflow as possible.

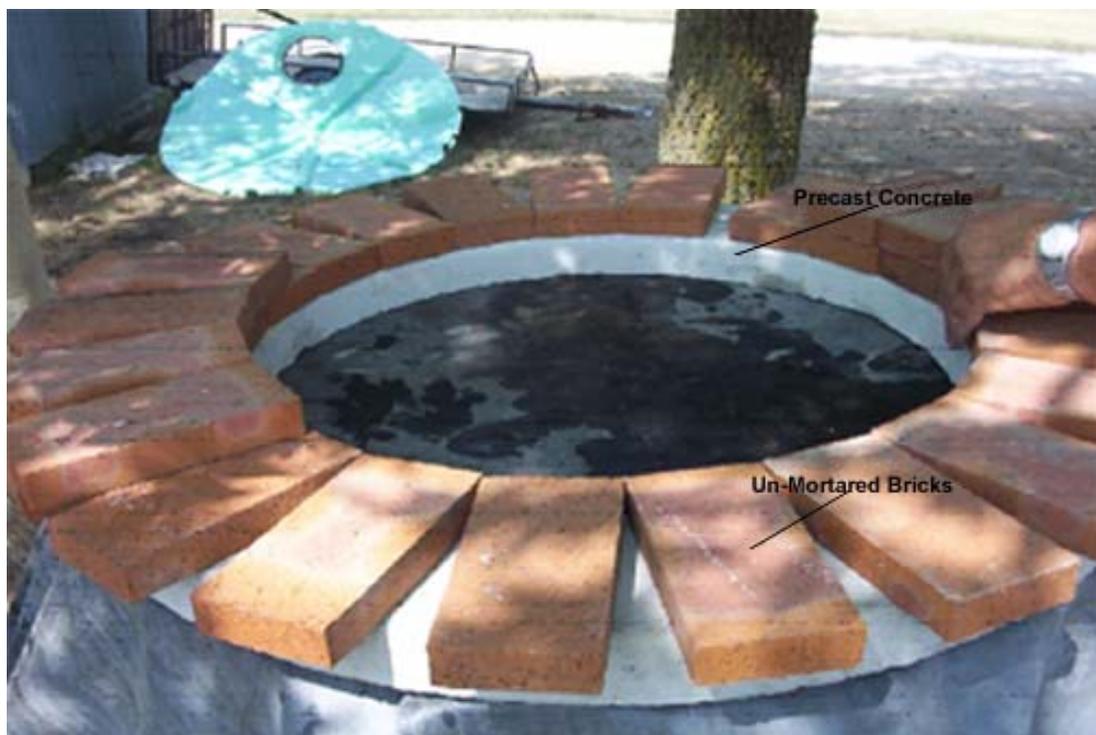
Manhole Test Assembly: A full-size precast concrete manhole concentric cone section was used as a base for the test assembly. A chimney was constructed on top of the cone section, consisting of two courses of un-mortared brick over one precast concrete extension ring. A manhole frame was installed on top of the chimney. (see Figure 1).

Figure 1. Constructing Manhole Chimney

To simulate saturated ground conditions, a four (4) foot diameter, galvanized steel pipe section was set vertically over the top of the manhole section. The annular space between the steel pipe section and the outside of the manhole chimney was filled with clean crushed limestone. The crushed stone backfill extended below the manhole chimney, and was brought up to an elevation just above the lower edge of the manhole frame.

A flexible membrane liner was installed below the crushed stone backfill. The flexible liner was anchored to the manhole cone section beneath the precast concrete extension ring, ran down the cone section to the surrounding steel pipe, and then extended up and over the top edge of the surrounding steel pipe. The flexible liner allowed the crushed stone backfill surrounding the manhole chimney to hold water.

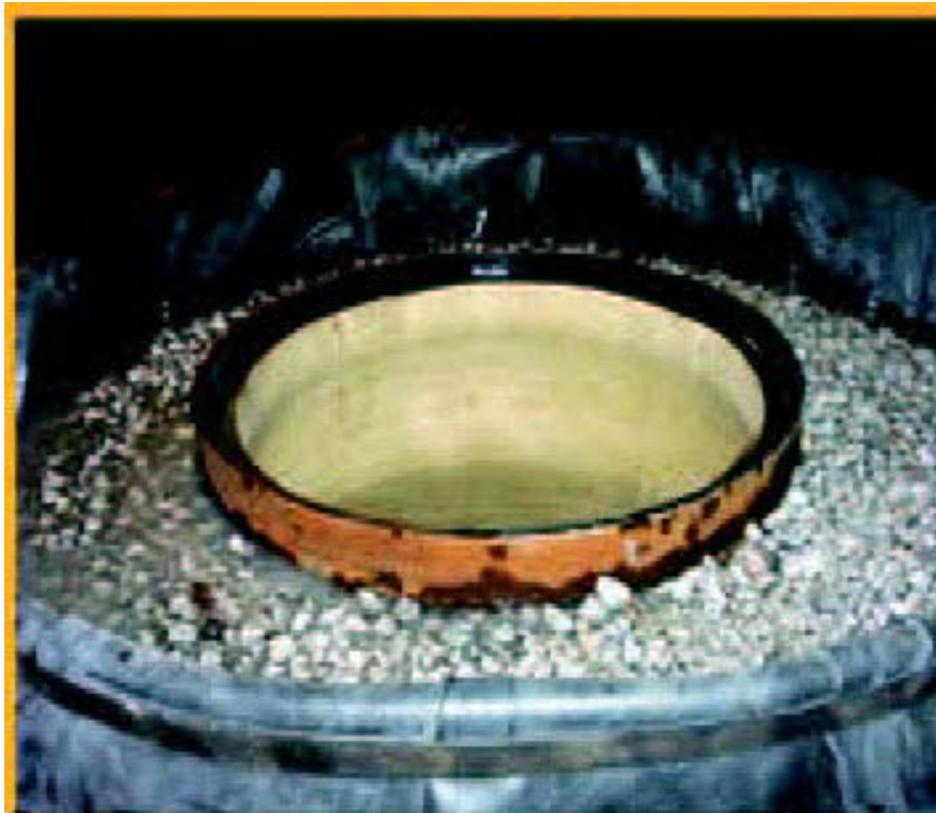
Freeze/Thaw Test: The entire manhole test assembly was transported to a large underground freezer. Temperatures inside the freezer were maintained between negative fifteen (–15) and negative eighteen (–18) degrees F. After arriving and prior to placing the assembly in the freezer, water was added to the stone backfill surrounding the lined manhole chimney. The water was brought to a level just above the bottom edge of the manhole frame, causing the area surrounding the chimney to be completely filled with water.

Picture 3. Manhole Test Assembly with Flooded Backfill

The manhole test assembly was placed in Freezer Number sixty-one (61) on Thursday, August 11, 2005. The test assembly was removed from the freezer on Monday, August 15, 2005. The entire assembly, including the water surrounding the chimney, was obviously frozen. The manhole was observed on Tuesday, August 16, 2005 after thawing (see Figure 4). No changes in the condition or appearance of the chimney liner were noted. There were no signs of separation between the liner and the manhole frame, chimney, or cone section. There were no signs of leakage observed. Measurements were taken of the water level surrounding the chimney, and the measurements showed no measurable water loss.

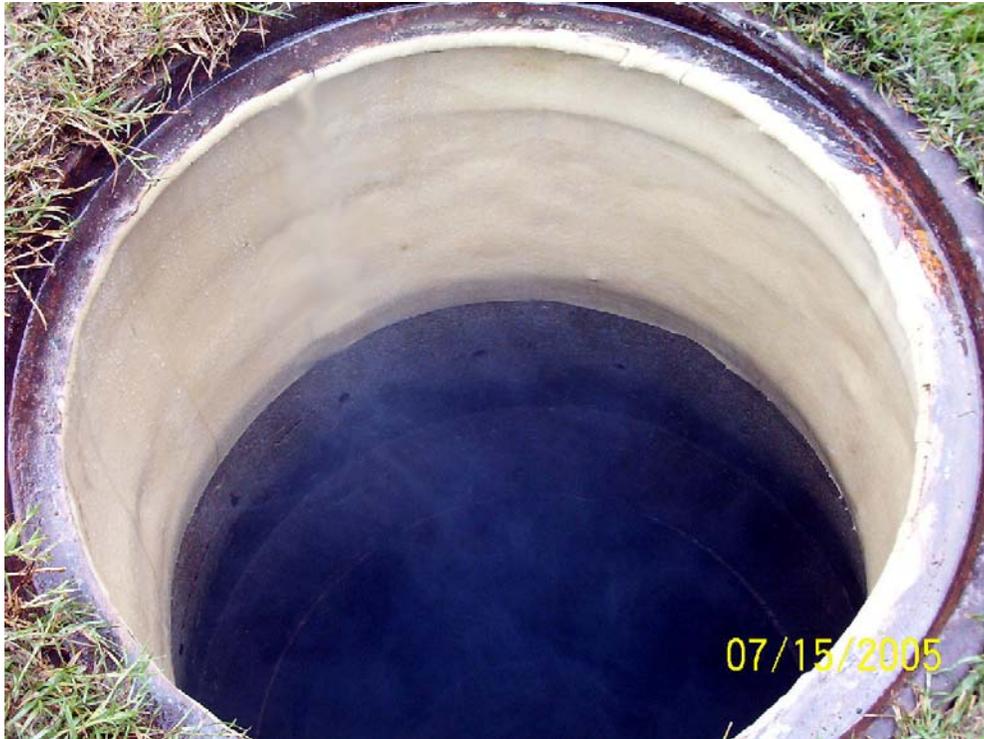
The test assembly was returned to the freezer mid-day, Wednesday, August 17, 2005. The frozen manhole assembly was removed on Friday, August 18, 2005. The thawed manhole was transported to the testing site on Monday, August 22, 2005 for final observation. The chimney liner exhibited no change in appearance. There were no signs of separation between the liner and the manhole frame, chimney, or cone section. There were no signs of leakage observed. There was no measurable loss of water in the stone backfill surrounding the chimney.

Figure 4. Chimney Liner after First Thaw

It is our observation that, following two freeze/thaw cycles, that the manhole chimney liner showed no change in appearance or condition. The liner appeared to be tightly adhered to the manhole frame, chimney and cone section at the conclusion of the field testing. No evidence of leakage through the chimney was observed during or at the conclusion of the test.
