Northcrest-Afton Sewer Rehabilitation Project

## **Multiple Technologies -- Maximum Flow Reduction**

James W. Shelton<sup>1</sup>, and Michael T. Harmer<sup>2</sup>

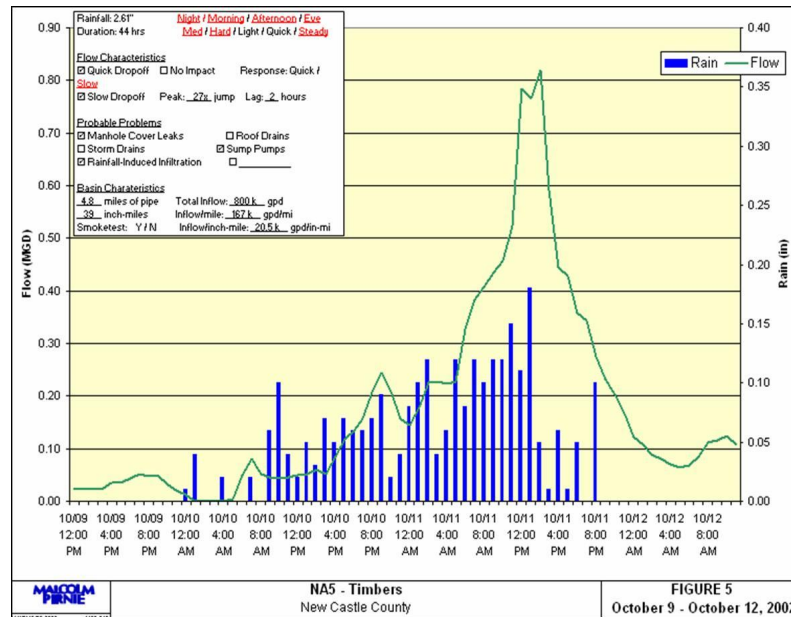
Figure 2: Storm Hydrograph

The HCA confirmed reports from NCC's Operations Department that the sewers of these two neighborhoods leaked badly. Flow meter data suggested these sewers suffered extended rainfall-induced infiltration and illegal sump pump or punctured floor drain impacts during and after storms. Night-time weiring showed baseline infiltration during normal springtime generally exceeded 10 gpm/linear feet of sewer main, and in some cases many times that rate.

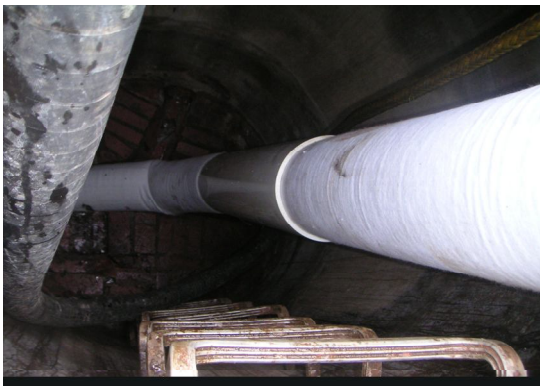
Figure 10: CIPPL Restrained Pipe Sample

To design the thickness of the liners, actual ASTM D2990 data of the resin were used to determine the long term creep modulus. To prove the installed product would provide the minimum design life of 50 years, restrained pipe samples of the installed product were tested for thickness, ASTM D2990 long term creep modulus, and ASTM D790 short term flex modulus.

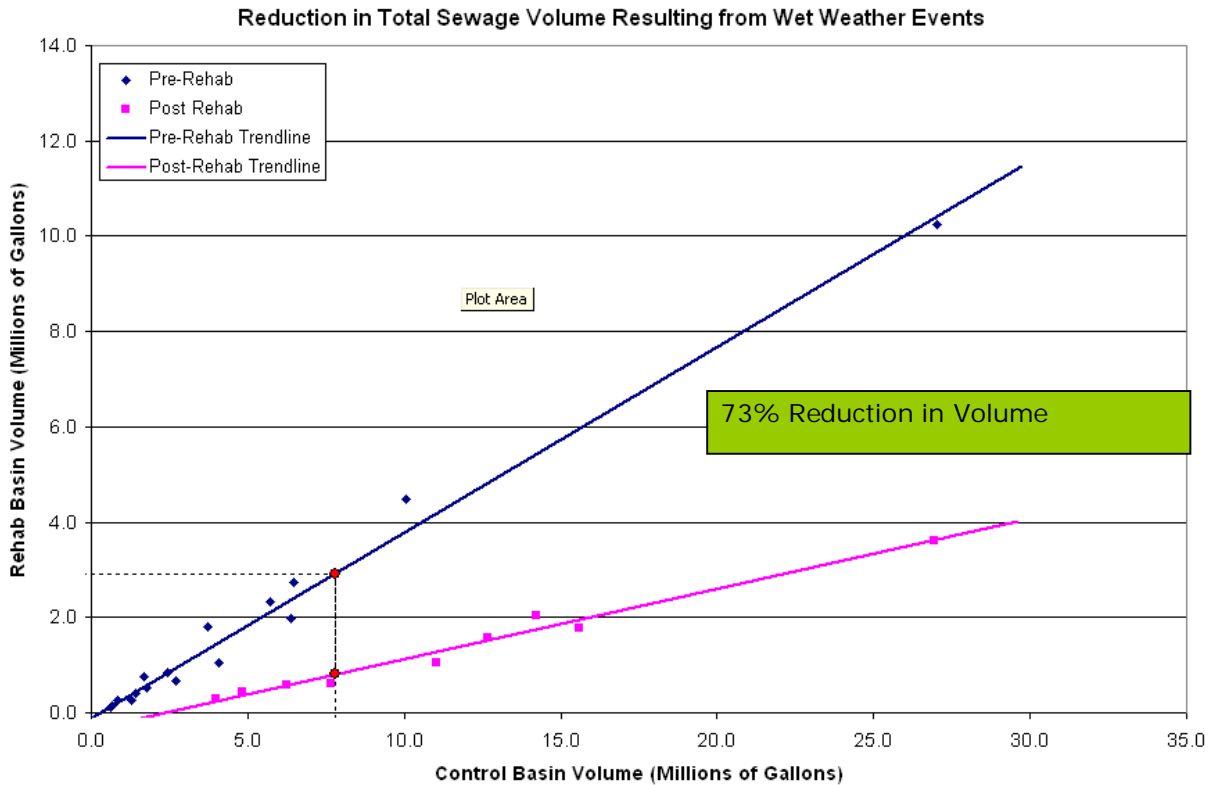
Figure 16: Total Flow Reduction – Control Basin Method

As shown in Figure 16, total flow resulting from rainfall events was lowered by 73%.

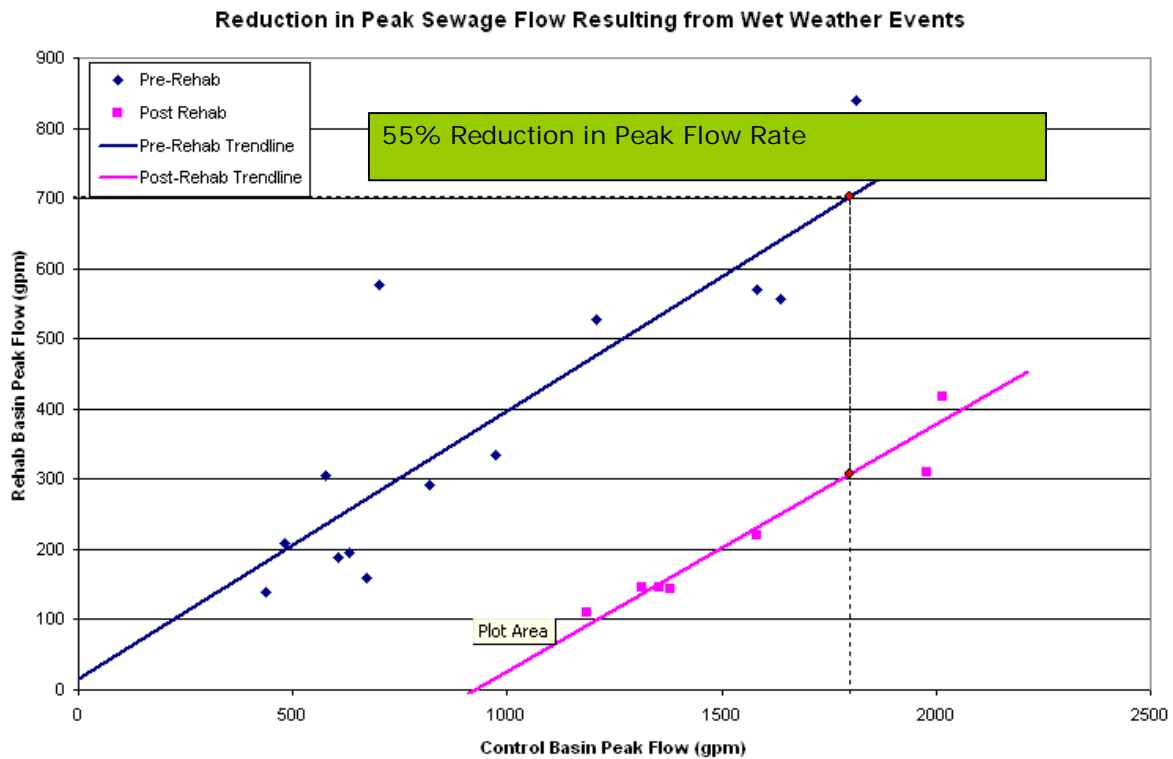
Figure 17: Peak Flow Reduction – Control Basin Method

As shown in Figure 17, peak flow rates resulting from rainfall events was lowered by 55%.
