North American Society for Trenchless Technology (NASTT)
NASTT's 2014 No-Dig Show

MA-T3-02

Rehabilitation of the Coral Gables Wastewater Collection System

Sahar Hasan, LMK Technologies, Ottawa, IL
Mark Gulyas, LMK Pipe Renewal, Ft. Lauderdale, FL
Jorge Acevedo, City of Coral Gables, Coral Gables, FL

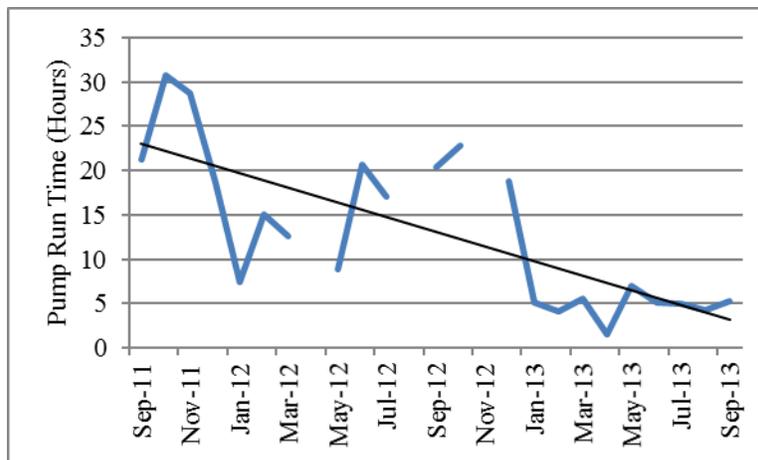
Figure 7: Decrease in Pump Run Times of Station A

This project was a small yet challenging job with big results that had major impacts on the entire collection system. The average daily flows and pump run times of the San Pedro/Lugo Station are demonstrated below in Tables 2, 3 and Figure 7. The pump run times went from a high of 30.81 hours in October of 2011 to a run time of just 4.23 hours per day post rehabilitation in August of 2013— essentially resulting in 86% decrease in pump run time.
