CASE STUDY: EMERGENCY REPAIRS: STOPPING A 40-FOOT SINKHOLE TO SAVE A HIGHWAY

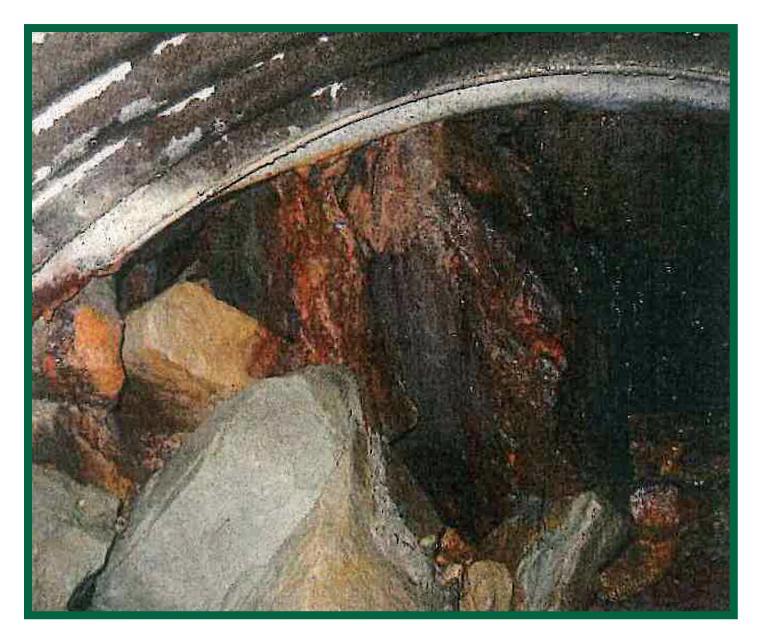
"After 30 or 40 years, that pipe was rusted and corroded, and the weight of the overburden caused it to collapse. It wasn't just dirt, but rocks and boulders from the fill material," which had created an urgent situation. The corrugated metal pipe was likely made of galvanized steel, as it was the standard coating of that time. Since then, several premium coatings have been developed that provide 75 years or more of service life.

Boulders and debris from the collapse

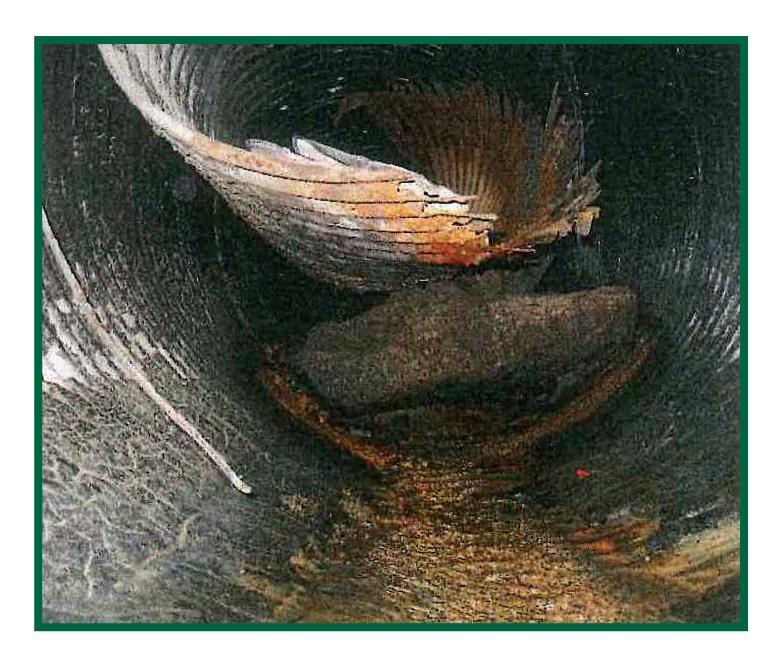
The old pipe had collapsed and twisted.

"Right past the junction pipe there was a big, twisted piece of corrugated storm pipe that was up inside the line. It had elongated, curled up, and was wedged in place," says Bell. He adds that the pipe had stopped 150 feet from where it had come loose.

Removing this source of the problem was essential to any further work, so after cleaning around the pipe to free it up, crews burned holes into the metal, put in a clevis, and pulled it free and out of the line using a powerful winch.

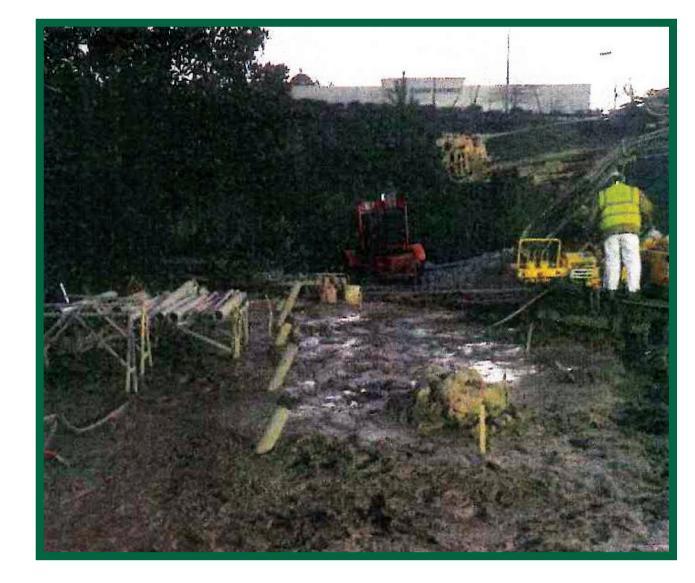
Compaction grouting was injected around the failed section of pipe to make a safe work area.

Before the installation of the tunnel liner plates, says Brown, crews used their drilling and grouting capabilities to drill 65 feet down, at an angle, from the outside surface to inject compaction grout around the failed section of pipe to provide safety for the installation of the liner plates. "We basically created a dome of grout around the work area."

Malone adds, "This was a really smart thing to do, as this fills in the voids and the earth overburden." Stabilizing the area allows the debris removal to be done in sections. "You couldn't remove it all at one time because it would cave in."

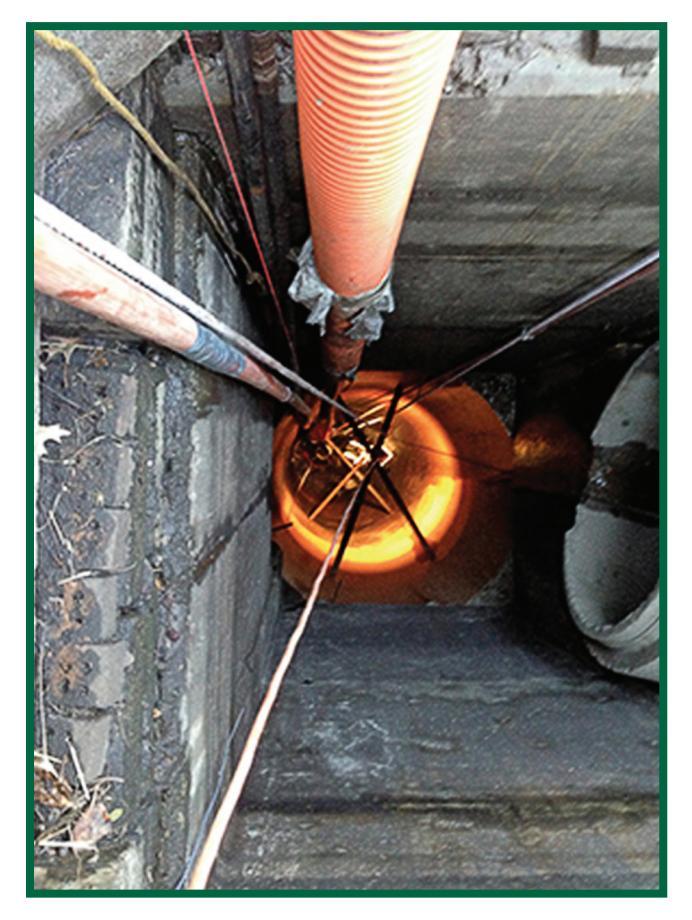
Looking down into the 72-inch-diameter stand pipe at The Summit. The orange hoses are being used to pump water from the bottom of the stand pipe.

With safety as the utmost priority and before any work was done, says Brown, crews built and installed a plug that was attached inside the 72-inch vertical pipe about 15 feet below the surface.

"This plug was essential to keep water away from our workers and keep them safe, and we also had a 65-foot vertical pipe attached so we could continuously pump water out as well."

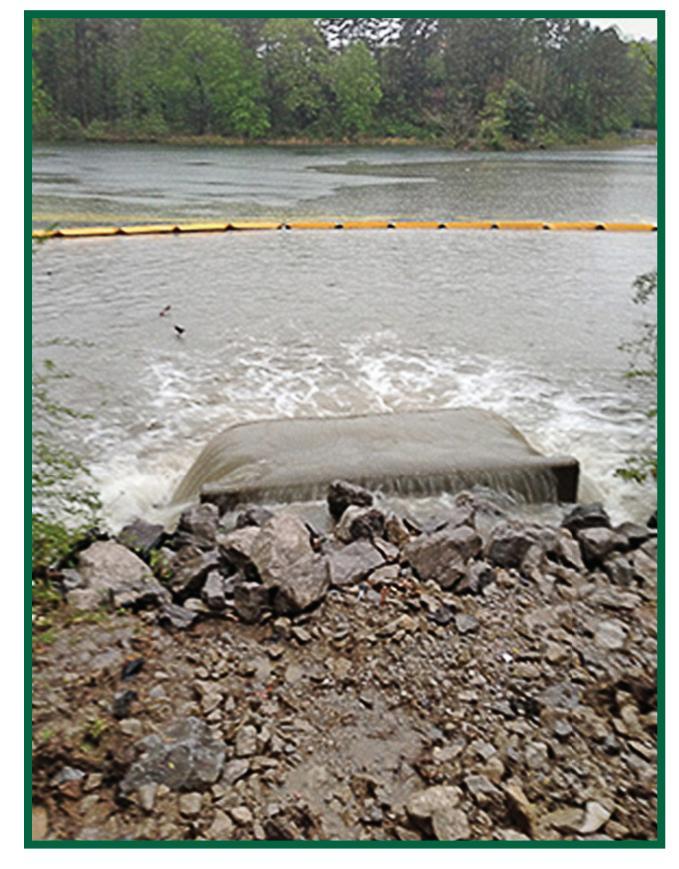
The receiving lake on the AT&T campus after work was completed

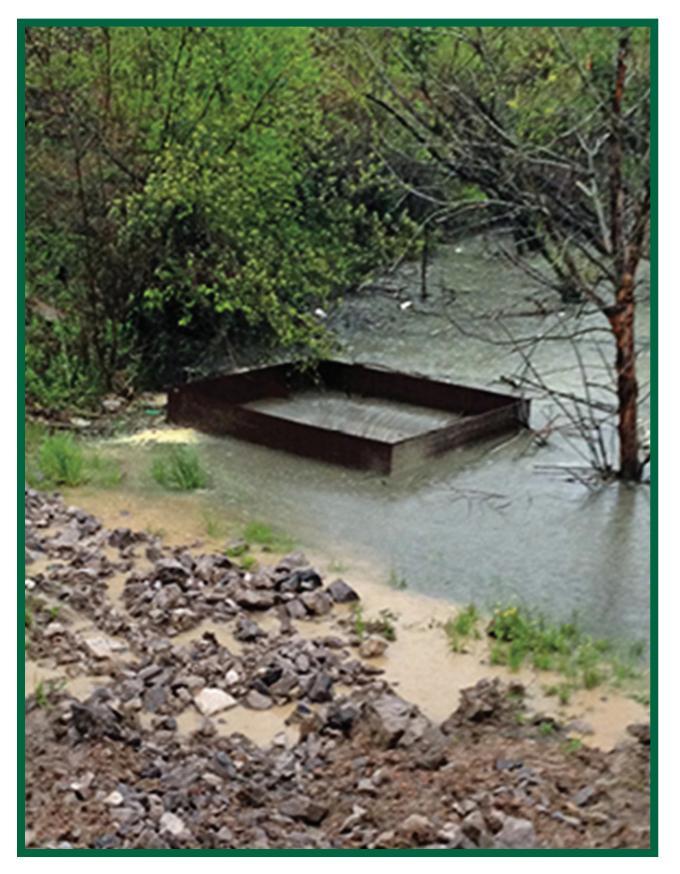
The inlet at the pond on The Summit side after work was completed
