The *Original* Centrifugally Cast Concrete Pipe (CCCP)

CentriPipe® – The original, patented, and proven system for trenchless, structural, and cost effective pipe rehabilitation.

Engineering and Design

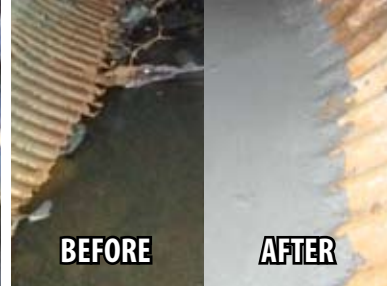
BOX CULVERT

BEFORE

AFTER

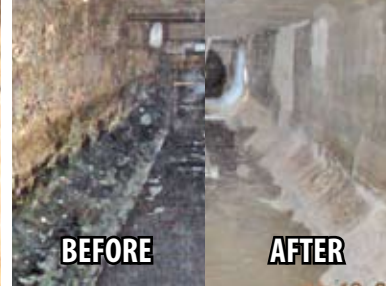
ELLIPTICAL PIPE

BEFORE

AFTER

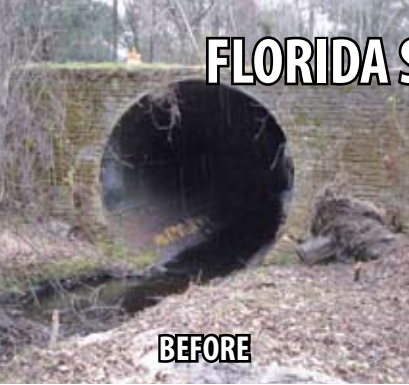
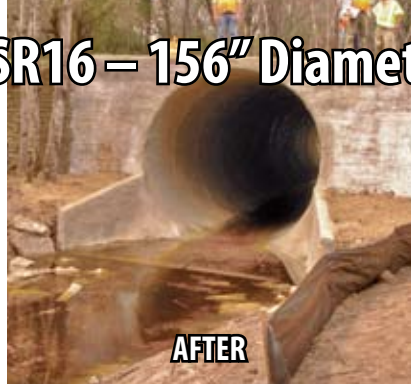
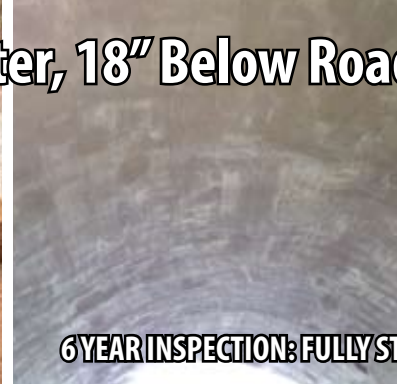
FLORIDA SR16 – 156" Diameter, 18" Below Road Surface

6 YEAR INSPECTION: FULLY STRUCTURAL, HIGHLY DUCTILE
