CASE STUDY: KEEPING THE TRAINS RUNNING: MUDDRUCKERS COMPLETES CHALLENGING TRENCHLESS CULVERT REPAIRS FOR CN RAIL

KEEPING THE TRAINS RUNNING: MUDDRUCKERS COMPLETES CHALLENGING TRENCHLESS CULVERT REPAIRS FOR CN RAIL

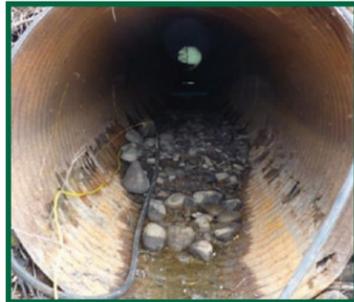
**Debris in pipe
before cleaning**

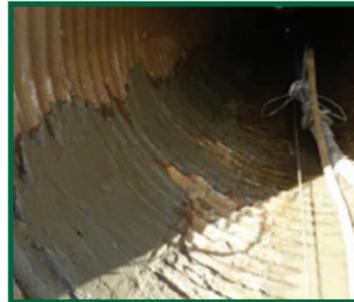
**Patching and leveling of the
invert using PL-12,000, and
self-leveling material with
12,000 psi**

To repair the rotted-out invert, MuddRuckers poured two layers of PL-12,000, a self-leveling cementitious product from AP/M Permaform. This created the smooth, level surface needed for steady spincaster withdrawal. PL-12,000 was also used for patching and repair of peeling sections of CMP.

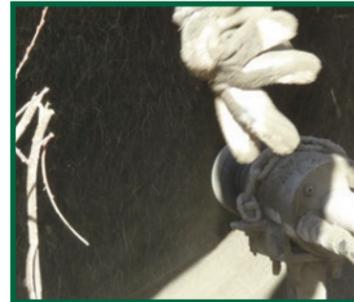
**Centrigally casting
fine-aggregate composite
concrete material, PL-8000,
with CentriPipe spincaster**

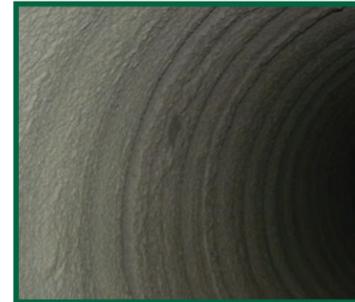
**Interior walls of rehabilitated
culvert are smooth,
structurally sound, and
water-tight**

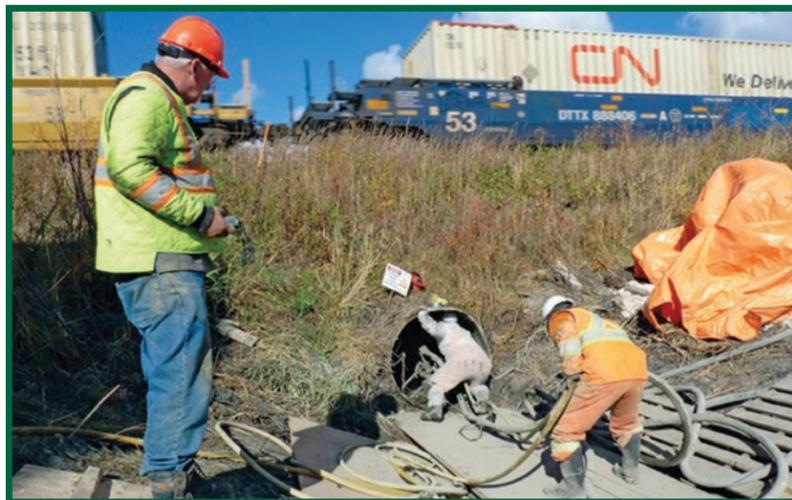
MuddRuckers Concrete Leveling & Lifting, based in Winnipeg, Manitoba, are the pioneer users in their region of a well-tested trenchless pipe repair solution from AP/M Permaform known as CentriPipe, a centrifugally cast concrete pipe (CCCP) process.

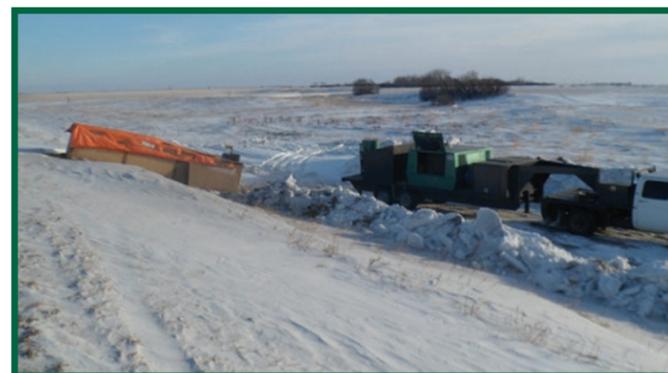
Enclosed heated and insulated workspace enables winter application of centrifugally cast, high-strength fine aggregate composite concrete rehabilitation material

4-ft x 6-ft and 4-ft x 8-ft panels, made of plywood and rigid insulation were used to build walls around the culvert ends, and the walls were covered with insulated tarps to create large hoardings.

“This is a system that is fast and easy to put up,” Cook says. “And it’s flexible enough to match uneven grades.” With end enclosures in place, ground thaw heaters and hoses were introduced and left in place for a few days; this brought temperatures up in the existing culvert, and melted ice so that dewatering could take place. Muddruckers has also learned that heating mix water improves quality, so water heaters are used during actual spincasting.

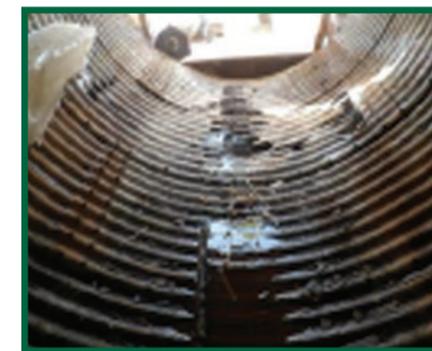
Rusted invert of culvert prior to rehabilitation

Another particular challenge of this project was the culvert condition. Though rusty, the CMP was mostly intact. However, the culvert was relatively clogged with mud and debris. After most physical debris was removed, MuddRuckers used a vacuum truck to remove mud and dewater the culvert, and completed the culvert preparation with scouring. In this case, the existing pipe was sound enough for spincasting to proceed, but on some projects pipe wall patching is needed and, fairly often, new inverts are poured to provide a smooth surface for even sled withdrawal. Unusually, there were some interior brackets in this culvert.

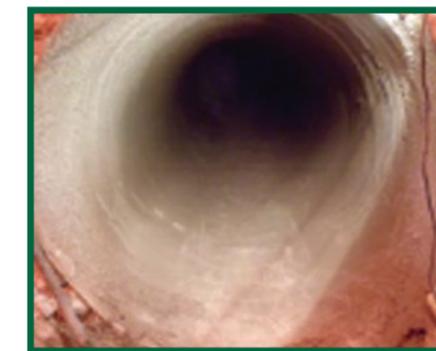
Structurally sound, water-tight, rehabilitated culvert

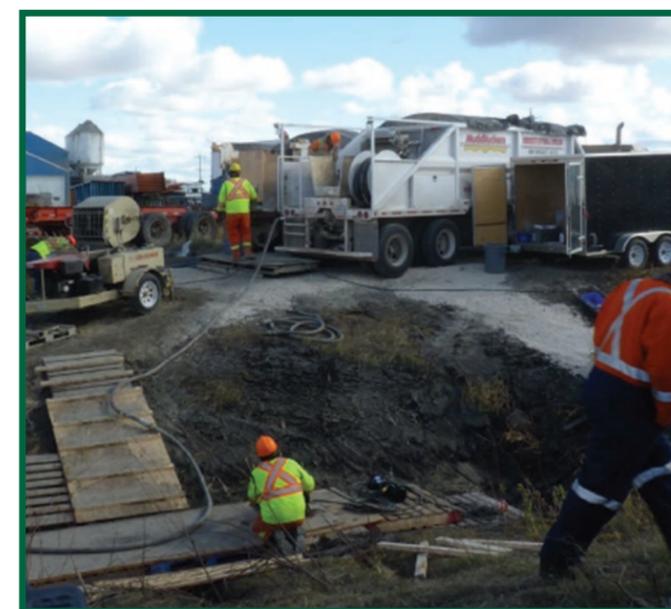
Site prep and staging included dewatering and a network of pallets to provide secure footing on the muddy terrain

pumping,” Cook explains. “We also had to dig a small hole right in the middle of the culvert, barely a foot deep, basically to collect water and so we had a place to put a hose end in. We filled it with concrete just before spincasting.” Mucky conditions also meant that the staging area needed extra attention; pallets were put down for secure footing and anchors were used as needed on the withdrawal winch.
