## **MLR — MAIN LATERAL REPAIR**

MLR — Main Lateral Repair is a structural one-piece, full circle CIPP liner renewing 18 inches and 360° of the mainline extending up the lateral pipe as one continuous lining to a maximum length of 150 feet.

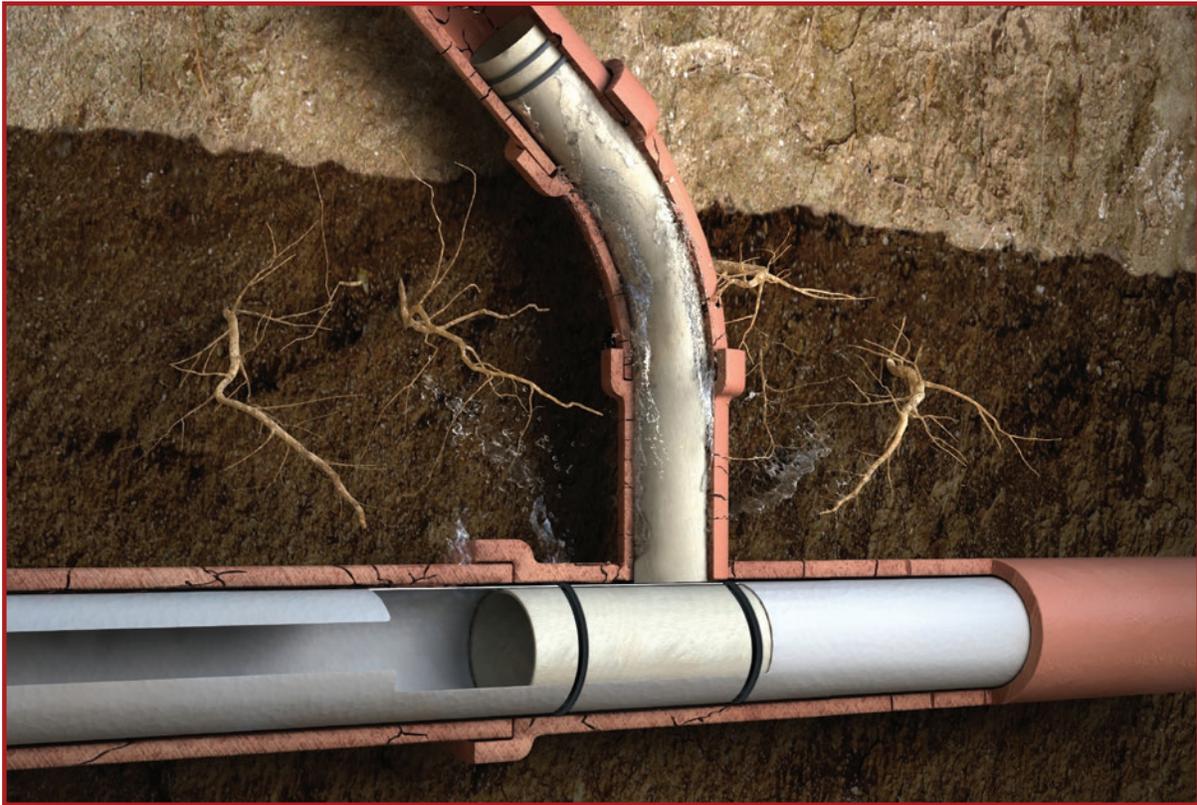
- Fully restores the structural integrity of the host pipe
- Provides resistance to root intrusion
- ASTM 1216 compliant
- Smooth, tapered transitions to host pipe for maximum flow
- Uniform wall thickness
- Utilizes hydrophilic caulk and molded O-rings as seals between the liner and host pipe walls
- Mainline pipe diameters from 6 to 24 inches
- Multiple solutions available
